After Action Report

5114 Mesker Park Drive

Single Family Residential Structure Fire

November 27, 2017

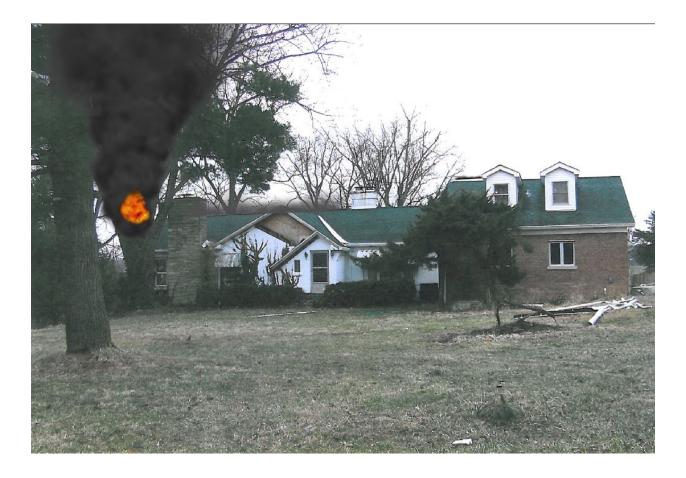
The crew attempted an external size up. It is estimated they completed about 3/4 of the exterior size up before deciding to begin putting water on the fire from the interior. Command was transferred and a 360 degree size up was completed. This size up brought up concerns about the size of the fire, crew access to the seat of the fire, rapidly changing smoke conditions. Command contacts the interior crew to determine their status. Interior crew says they are at the seat of the fire. Command is not seeing progress and is about to order evacuation when a backdraft occurs. The pressure from the backdraft dislocates a portion of the wall on the B side. The pressure also dislocates several windows on the A side. The interior crew does not respond to radio requests. Command declares a mayday. The photo below is a simulation of what the initial crew saw upon arrival.
